Miller Motorsport

Ohio WM-2

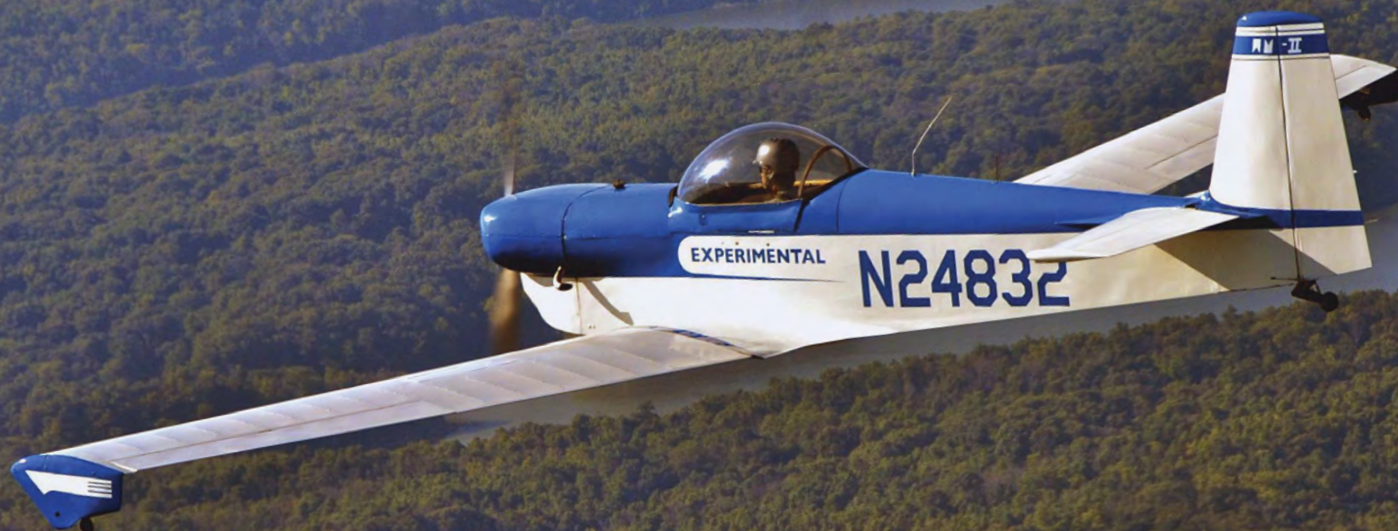
The first flight of the Miller Motorsport was in 1972. It appeared in an article in *Sport Aviation* in May of 1973. The airplane has a single retracting landing gear. The construction is wood and fabric and fiberglass. The 40-foot wingspan barely allows it to fit in a T-hangar.

The Miller Motorsport has a retractable single main wheel. An outrigger wheel is on each wingtip. The airplane taxis with one wingtip on the ground. It looks very awkward, and many people think something is wrong with the airplane. The landing gear is retracted by a Johnson bar handle.
